PASER Inspection &

Pavement Management Plan

Eureka, KS | Project No. 231019.00

City of Eureka, Kansas Pavement Management Plan

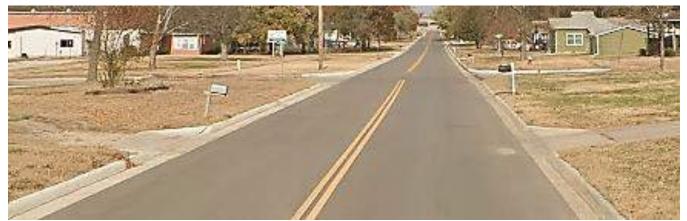
Figure 2-10: Example of "Excellent" Condition – Main Street This picture is from south of Main street north of 11th scored 10/10 because it demonstrates no visible pavement distresses.

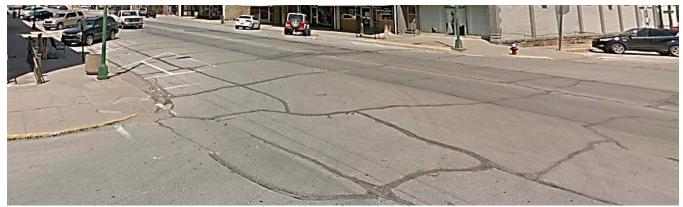
Figure 2-11: Example of "Good" Condition – Main Street This image is of Main Street at 2nd Street scored 8/10 and considered "Good" for an COM pavement. It exhibits longitudinal cracking and rutting but there are few issues, and each crack is sealed.

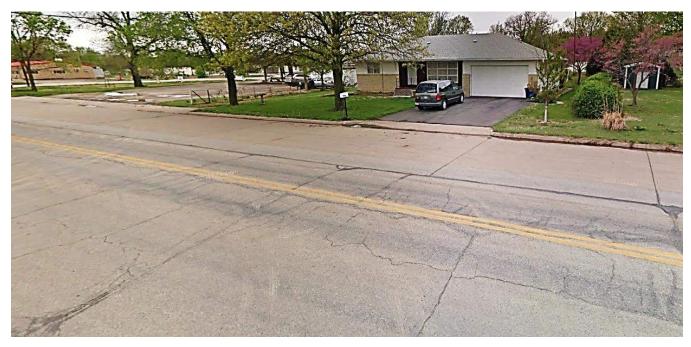
Figure 2-12: Example of "Fair" Condition – North Jefferson Street

This image of North Jefferson scored a 6/10. The distresses are widespread but mostly surface level. The block cracking remains mostly contained and there are no significant distortions. Simple rehabilitation methods would be effective to address these distresses.

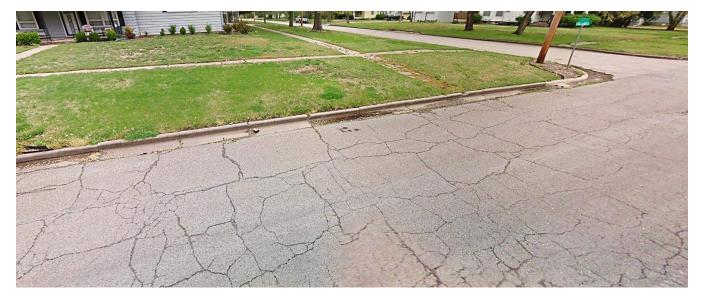
Figure 2-13: Example of "Poor" Condition – North Mulberry Street

This image of Mulberry street near 1st Street scored 3/10 and assigned a "Poor" rating. The block cracking is across nearly 100% of the street surface and there are significant distortions and failures along the gutter line where water gets trapped regularly.

That said, "Poor" pavements may still be salvageable without requiring excessive financial investment. The city should address these roads through Major Rehabilitations such as Mill and Overlays or localized "dig-outs" of severe distresses to provide repairs to the base material and then follow that by a surface treatment like Microsurfacing.

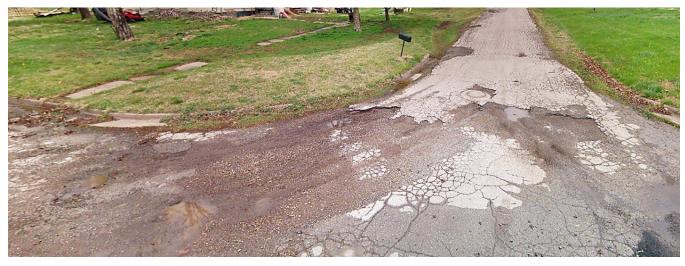
Figure 2-14: Example of "Very Poor" Condition – East 6th Street.

This picture of East 6th Street shows the portion identified as the worst street in the City. It scored a 1/10 which corresponds to "Very Poor" condition. This portion has several locations of complete failure where the pavement is washed out or obliterated.

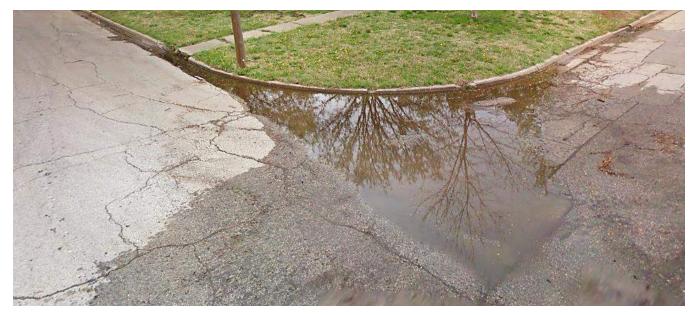
Figure 3-4: Ponding Issue

These factors are most noticeable on the east side of town particularly around intersections. Many intersections were identified as having ponding issues. The way the grades come together and the lack of intakes is leading to water getting trapped at the curb returns. This standing water then results in freeze-thaw damage and causes the underlying subbase/subgrade to deteriorate. It is common to see these issues cause sinking/heaving or the pavement crumbling into small pieces, both of which exacerbate the ponding problem

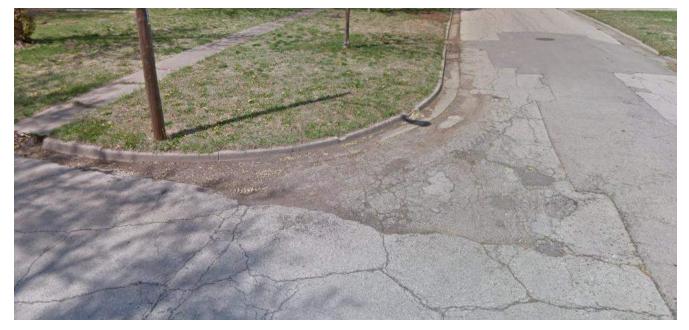
Figure 3-5: Results of Ponding

This photo shows the intersection of Plum and 2nd where repeated ponding has caused the curb return to obliterate and settle.
