PASER Inspection &

Pavement Management Plan

Eureka, KS | Project No. 231019.00

City of Eureka, Kansas Pavement Management Plan

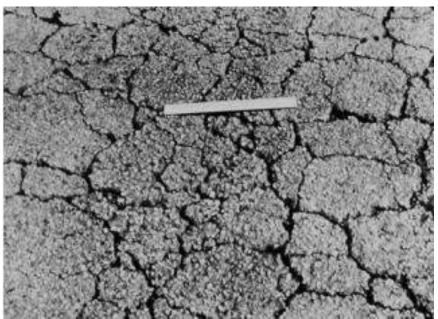
Figure 2-3: Example of Alligator Cracking (ASTM)

This image is from the ASTM D6433 "Standard Practice for Roads and Parking Lots Pavement Condition Index Surveys." Alligator Cracks are when pavement breaks into a "scaly" pattern typically caused by fatigue, either from repeated heavy loads, lack of sufficient subgrade support, or weakened material due to drainage issues.

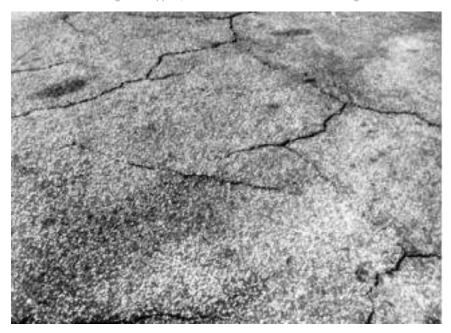
Figure 2-4: Example of Block Cracking (ASTM)

This image is from the ASTM D6433 "Standard Practice for Roads and Parking Lots Pavement Condition Index Surveys." Block cracks are when pavement breaks into "chunks" or "blocks" that are roughly rectangular, caused by internal stress from temperature or lack of lateral support.

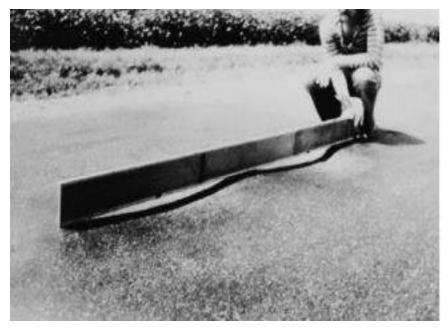
Figure 2-5: Example of Distortion (ASTM)

This image is from the ASTM D6433 "Standard Practice for Roads and Parking Lots Pavement Condition Index Surveys." Distortions are when the pavement warps its shape without significant cracking. Typically caused by shifting or displaced underlying material.

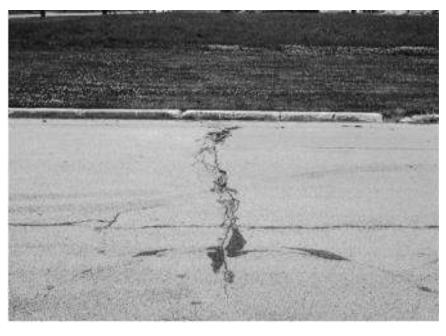
Figure 2-6: Example of Transverse Crack (ASTM)

This image is from the ASTM D6433 "Standard Practice for Roads and Parking Lots Pavement Condition Index Surveys." A common distress caused by a wide variety of issues.

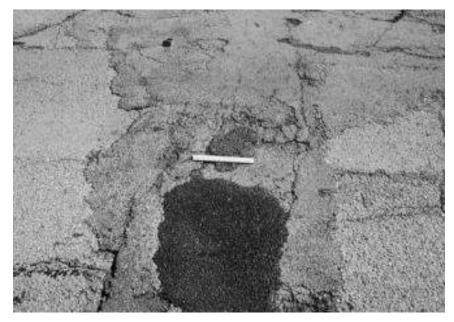
Figure 2-7: Example of Patching (ASTM)

This image is from the ASTM D6433 "Standard Practice for Roads and Parking Lots Pavement Condition Index Surveys." Patching is the result of corrective actions already taken and is indicative of underlying issues as well as a common point of failure.

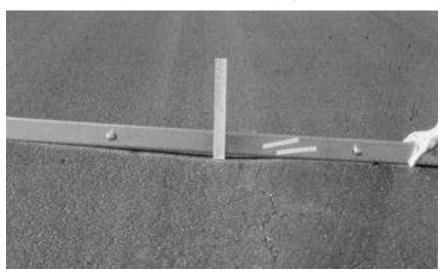
Figure 2-8: Example of Rutting (ASTM)

This image is from the ASTM D6433 "Standard Practice for Roads and Parking Lots Pavement Condition Index Surveys." Rutting is a depression along the wheel-path caused by traffic loads.

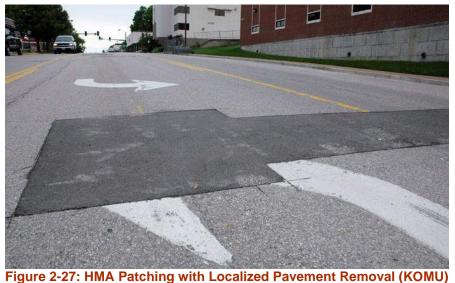
This is an example of an asphalt patch applied with appropriate localized removals and some base repair.

By default, surface patching should be performed using localized removals, cutting a rectangular or square shape into the pavement, and replacing it with new HMA pavement after ensuring the base-material is sound.
